PHASE I ENVIRONMENTAL SITE ASSESSMENT

FRESH WATER PUMPS ST. PAUL ISLAND, ALASKA

August 24, 2004

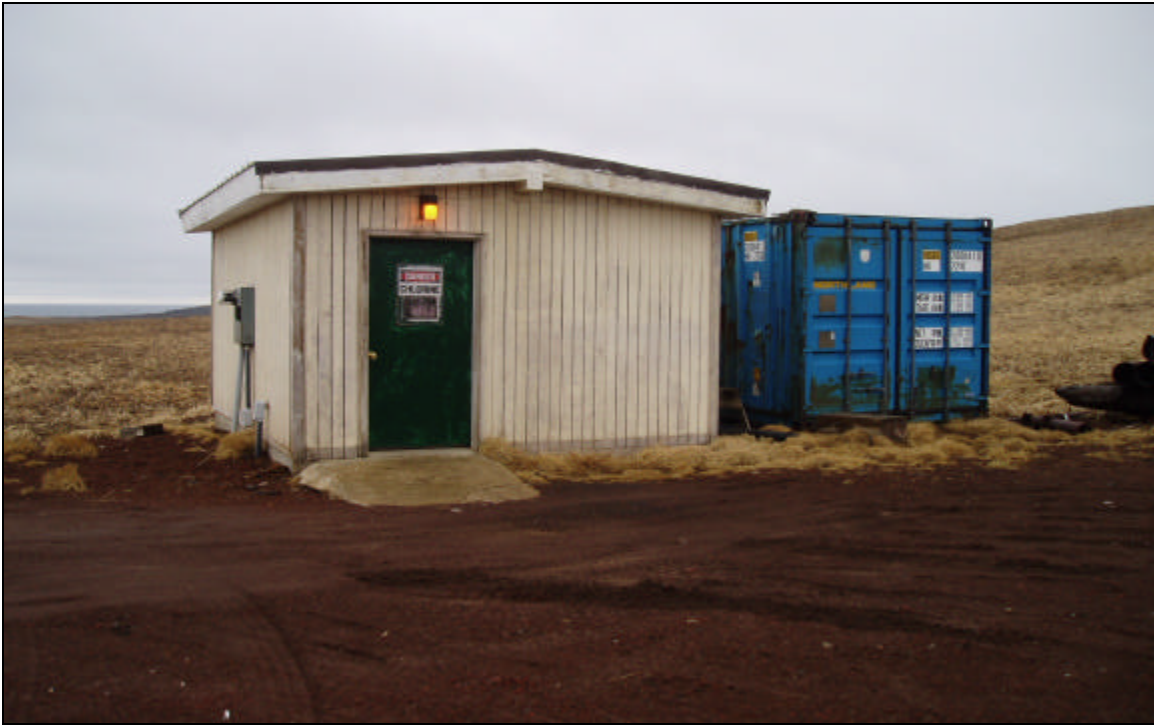
Photograph No. 1

Description: Looking south at the operational pump house and water treatment facility. The intermodal shipping container located to the right side of the pump house is used for storage of piping and pipe fittings.

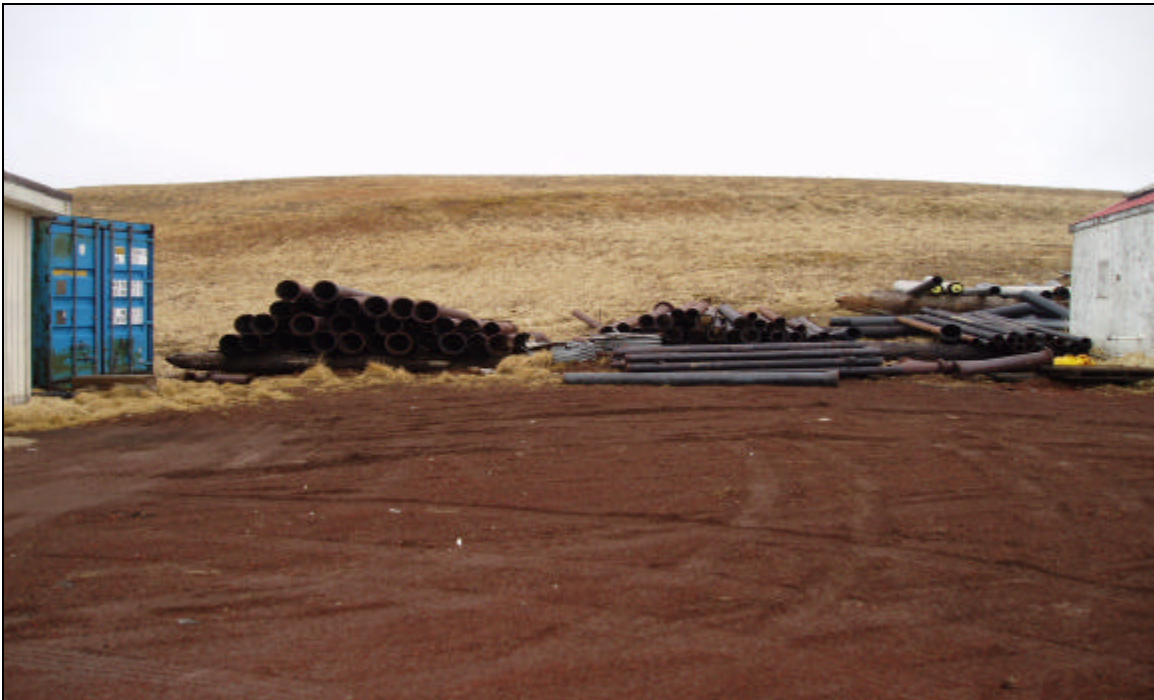
Photograph No. 2

Description: Looking west from the property. Piping and pipe fitting related to the upcoming installation of a new water line are visible in the background.

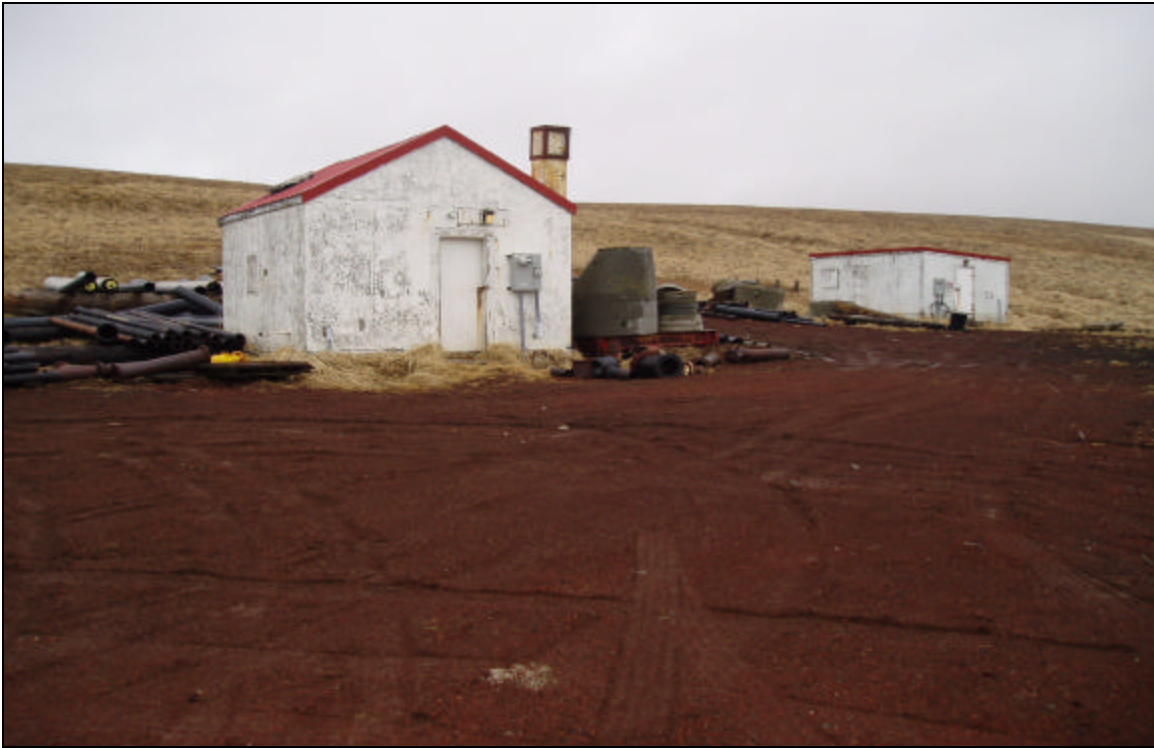
Photograph No. 3

Description: Looking northwest at the two non-operational pump houses. The pump house in the right background contains several 100-pound plastic containers of calcium hypochlorite granules and several 50-pound plastic bags of fluoride powder.

Observations: The interiors of the pump houses were inspected during the site reconnaissance. The currently operational pump house and one of the non-operational pump houses were found to be devoid of any containers of chemicals or containers of unknown use or origin. The other non-operational pump house, located to the north of the other pump houses, is currently being used as a storage room for water treatment chemicals, and was found to contain several 100-pound plastic containers of calcium hypochlorite granules and several 50-pound plastic bags of fluoride powder. The chemicals appear to be properly stored and no leaks or stains were observed in the pump house during the site reconnaissance.

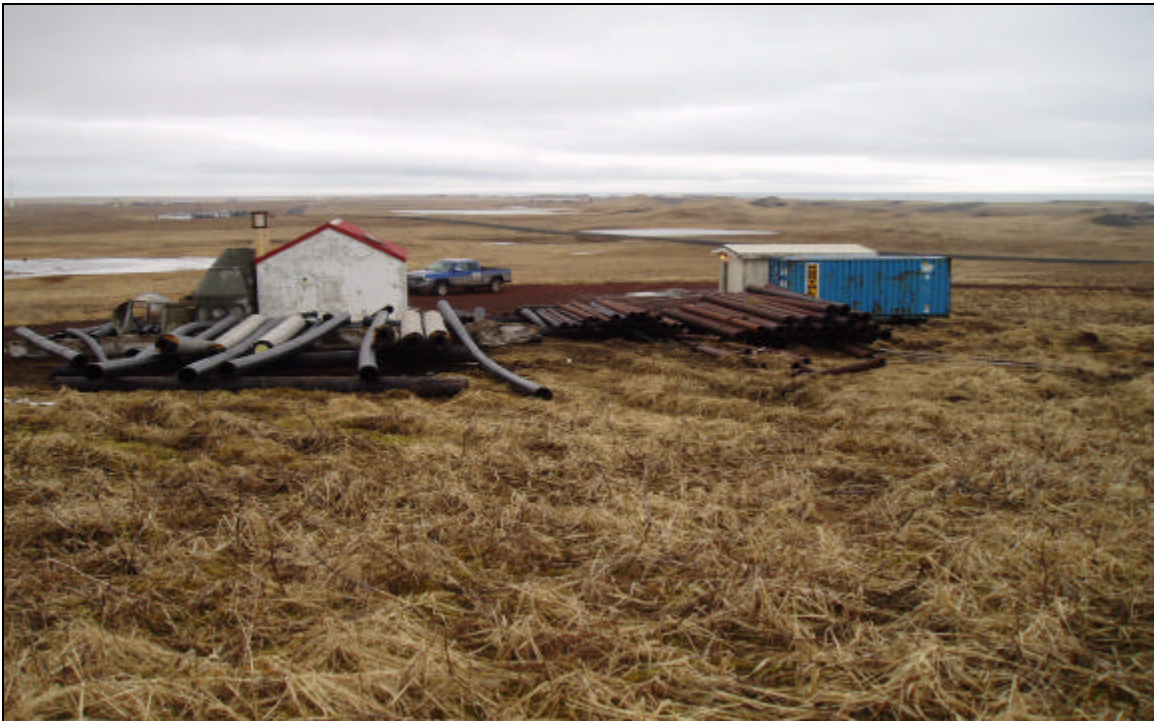
Photograph No. 4

Description: Looking east at the subject property.
